Scranton Passive House

RICHARD PEDRANTI ARCHITECT

SCRANTON PASSIVE HOUSE

Location	Scranton, PA
Area	2,100 sqft
Year	2015
HERS	28

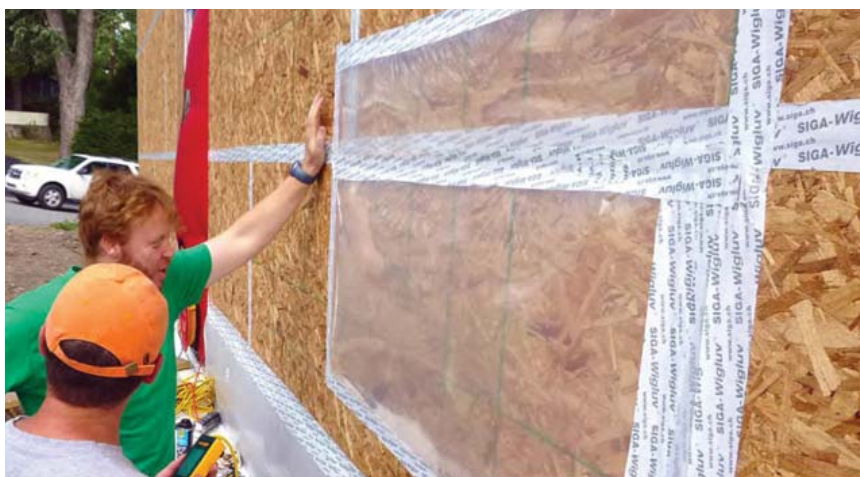
Balloon test #2 over OSB panel only

"We were all quite frustrated at that point, and our building performance consultant, Pete Vargo, suggested doing a positive pressure test and looking around outside," Pedranti wrote in his e-mail. "We reversed the fan and Pete said, 'Let's do a balloon test on the OSB just for fun.' We taped a piece of polyethylene over a portion of the OSB and taped it with Siga Wigluv. The polyethylene immediately ballooned up just like the shroud of the blower door, and Pete declared that we have leaky OSB."

Pedranti explained over the phone, “I wasn’t very excited to do this balloon test. I didn’t think it was true that the OSB was leaking. I thought it had to be the tape seams or the sill seal at the plate. We taped the poly up there and cranked the fan up, and it just happened instantaneously. We said, ‘This is unbelievable. How did we end up with this leaky OSB?’ I was quite upset.”
